## Conditions Assessment

Kansas City, Kansas

NOVEMBER 29, 2023  
WATERS EDGE AQUATIC DESIGN

Parkwood Pool – Physical Conditions Assessment  
Waters Edge Aquatic Design (2023)

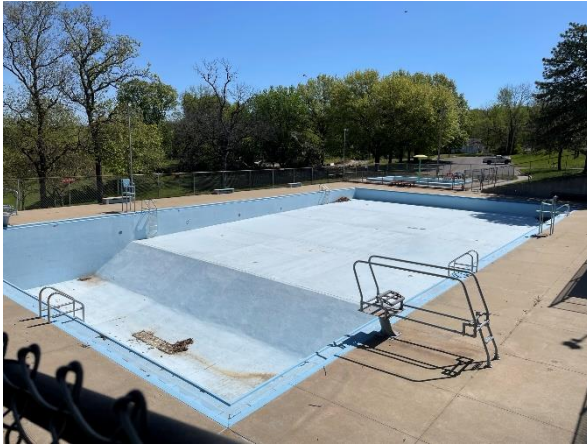
*Main Pool*

The concrete within the main pool basin appeared to be in good condition. During the inspection of the facility previous repairs of the basin were apparent and were observed. These observed repairs appeared to be in good condition, like the rest of the basin.

1. Locate and repair the source of water leakage.
2. Replace concrete gutter tile as needed.
3. Recoat the pool basins.

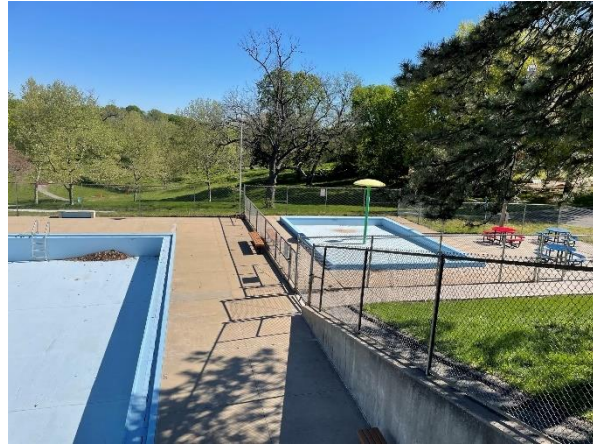
*Wading Pool*

- Wading pool basin has been repaired but appeared to be in good structural condition.
- The diatomaceous earth (DE) filtration system showed sides of limited remaining life.

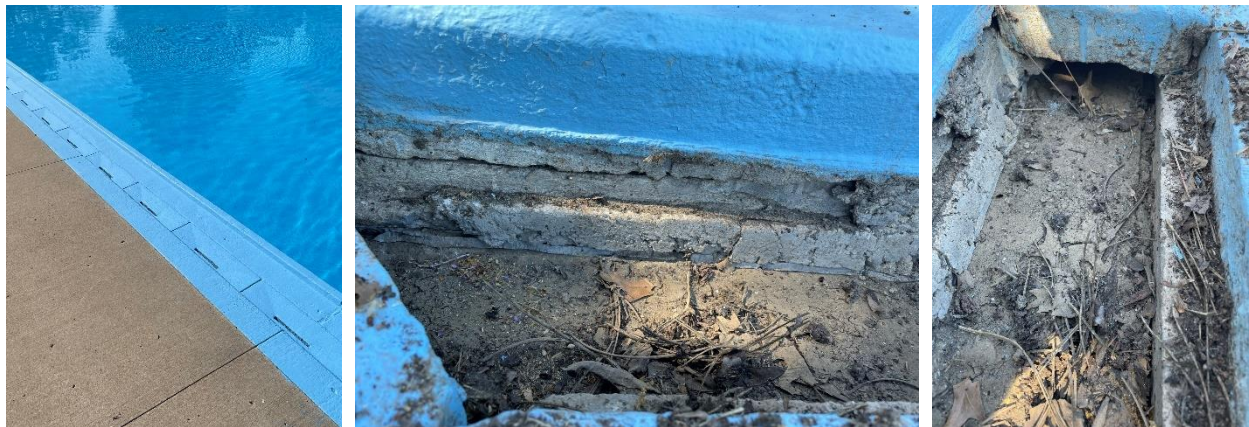
*Perimeter Gutter*

The perimeter concrete gutter tiles were inspected. The concrete tiles appeared to be in good condition. The gutter trough was also inspected in the accessible areas. Minor deterioration was observed in grout bed.

(Note: There were non-accessible areas due to the permanent affixture of the concrete tiles.)

Overall, the pool basins and perimeter concrete gutter appeared to be in good condition given the age of the concrete. The structures appeared to be sound with a reason amount of useful life remaining. However, there were a few items that need to be monitored if the facility is to remain in operation. These areas are:

- Cracking and damage of concrete gutter tiles.
- Deterioration of the concrete tile grout bed.

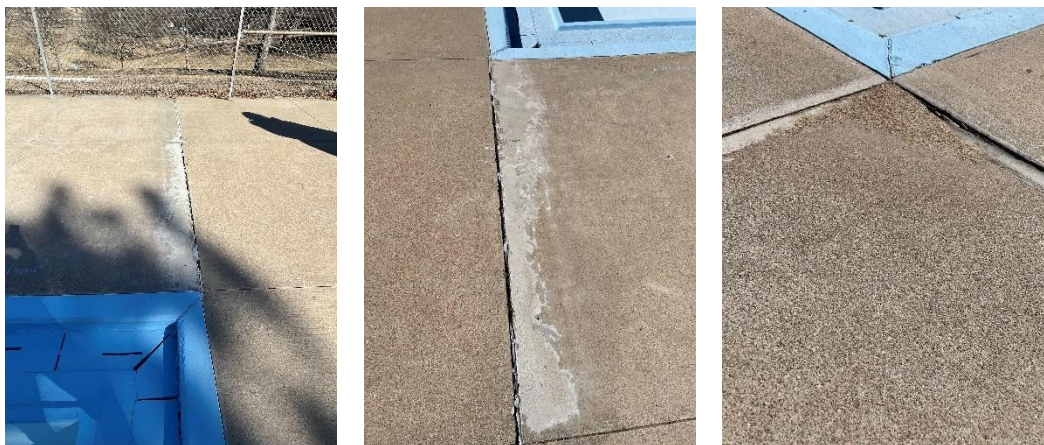
The Parkwood Swimming Pool deck appeared to be in fair condition at the time of inspection. There were a few signs of shifting or settling around the pool deck. The staff report that the areas have been patched and fixed yearly. These observed repairs appeared to be in fair condition, like the rest of the perimeter deck.

1. Monitor deck for any progression of shifting or settling.

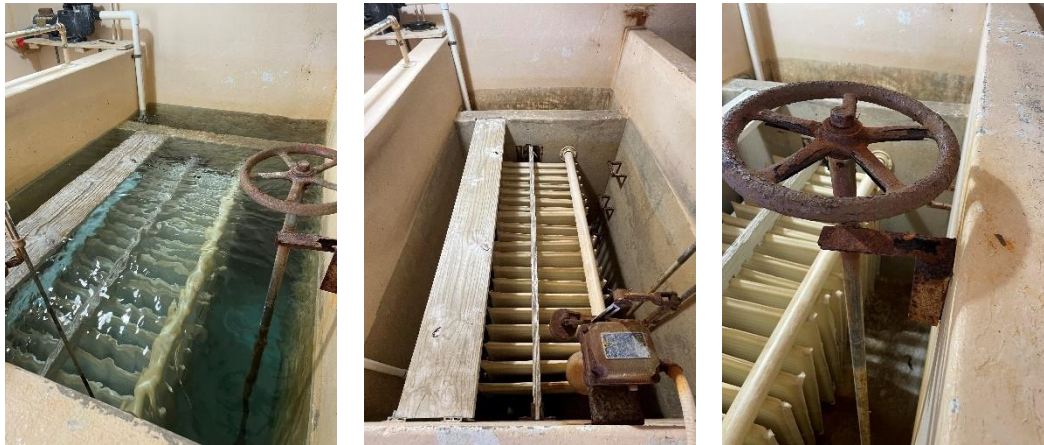
*Filtration Tank*

While the filter was in working order during the inspection it is recommended that staff consider a replacement plan for the filtration system. Decades ago, DE filtration systems were heavily used in commercial swimming pool facilities, like the Parkwood facility. However, within the last 10-15 years they have become less common due to their relatively high maintenance and upkeep requirements.

This decline in utilization has led to a reduction in available spare parts and knowledgeable servicing personnel. Therefore, it is recommended an alternative filtration system be planned for.

1. Replace filtration system.
2. Replace corroded valves.
3. Replace corroded metallic components.
4. Install a new pump, motor and strainer.

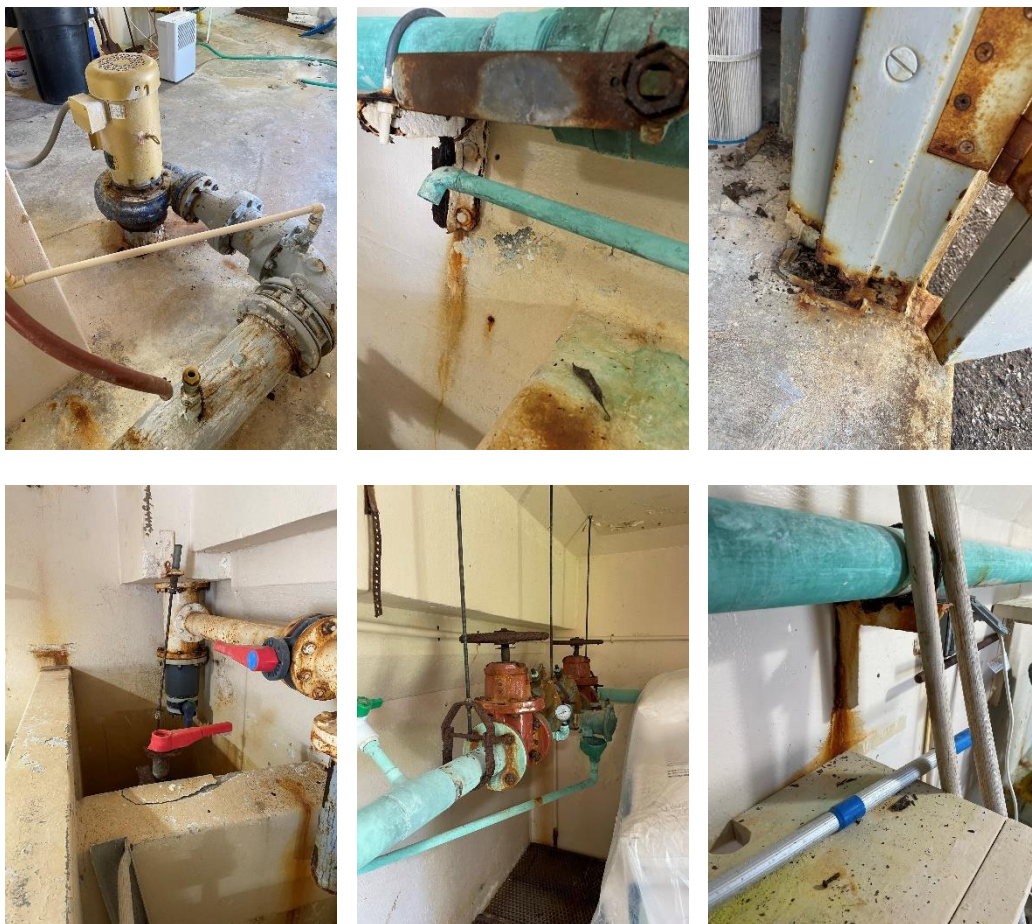
*Corroded Components*

During the inspection corrosion was observed on system valves and other ferrous metallic components. All corroded components should be replaced to optimize operations.

There was observed corrosion from the pipe connections and the pump housing. It is recommended that the pump and motor be replaced to improve the operations and maintenance. The following items of the pumping system have been identified as needing attention.

- There are no isolation valves on pump and motor. Installation of isolation valves will make servicing the pump motor easier for staff.
- There is no strainer basket upstream of the pump. Installation of a strainer would reduce wear from debris passing through the pump. Reduction of debris extends the life of the pump.

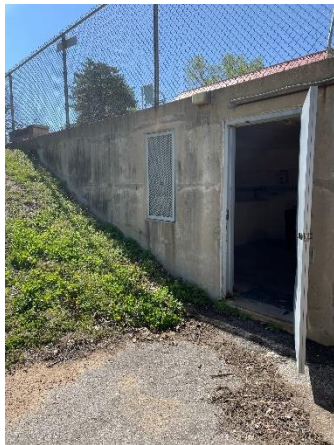
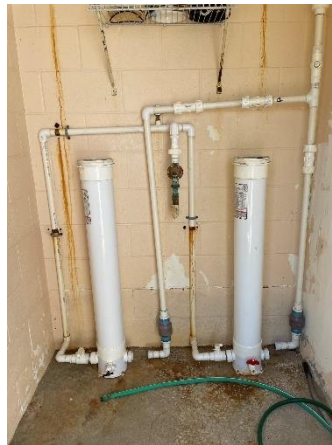
*Chemical Room*

At the time of the inspection the Parkwood Swimming Pool used a Pentair calcium hypochlorite system for water disinfection. The disinfection system was housed in the chemical room that is adjacent to the filtration area.

The calcium hypochlorite system appeared to be in good condition. Staff should continue to perform the manufacturer's recommended operations and maintenance plan.

If the facility remains in operation, it is recommended that automated chemical controller be installed to continuously monitor the chemical levels of disinfectant in the water. A chemical controller is a requirement of current health department regulations for public swimming facilities.

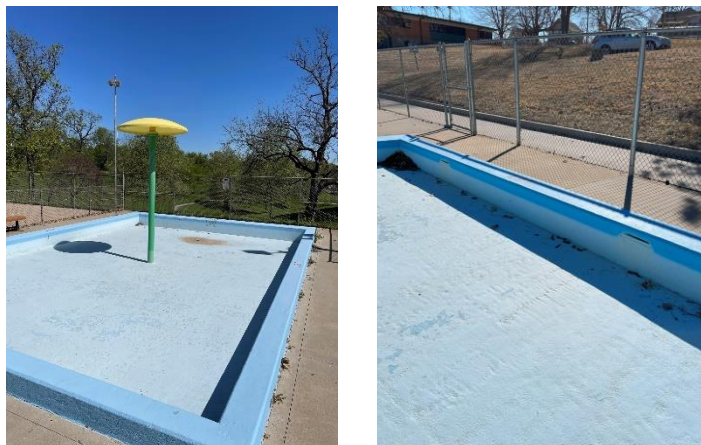
*Wading Pad*

The wading pool basin was in good condition at the time of the inspection. If the facility is to remain in operation it is recommended that the current preventative maintenance plan continue. A wading pool is an amenity that is a popular feature for young patrons.

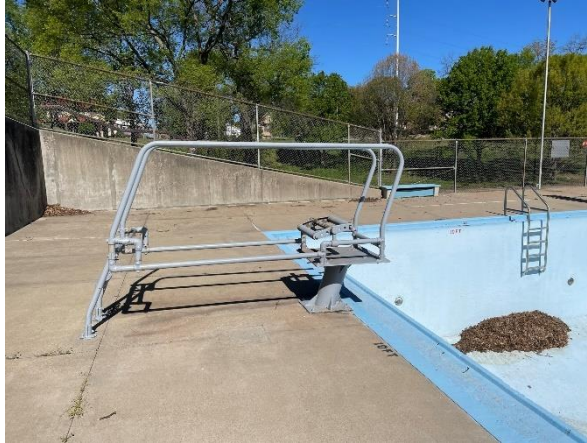
*Diving Stand*

There are two 1-meter boards in the deep area. The stands and boards seem to be in sound condition. The surface coating of the diving stand did exhibit signs of decline and corrosion. It is recommended that the stands be cleaned and recoated.

1. Recoat the diving stands.

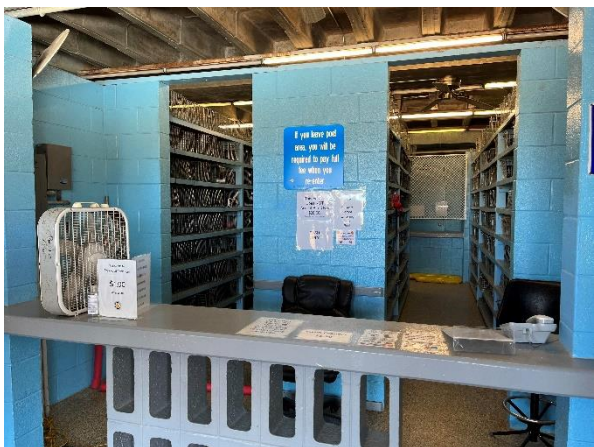
*Admissions*

At the time of the inspection the building appeared to be in sound condition. There were no observed cracks within the walls and floors. And the ceiling appeared to be in good condition.

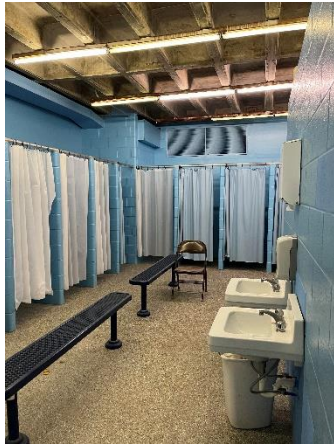
*Open Changing Areas*

The restrooms facilities are divided into Women's and Men's. The Women's side had adequate space for patrons to change. However, the Men's side did not have sufficient space. There were no changing stalls like the Women's side. Male patrons had to change in the toilet stall.

If the facility is to be renovated it is recommended that the Men's side be modified to create individual changing areas.

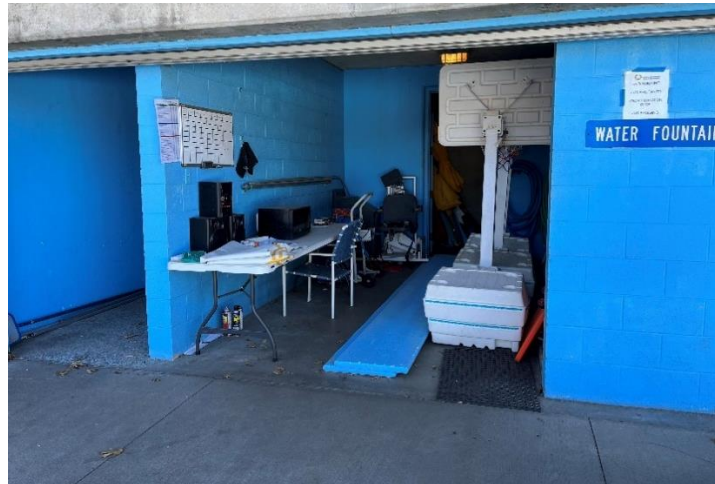
*Staff Area*

Staff space, first aid, office and storage are all shared in the same room.

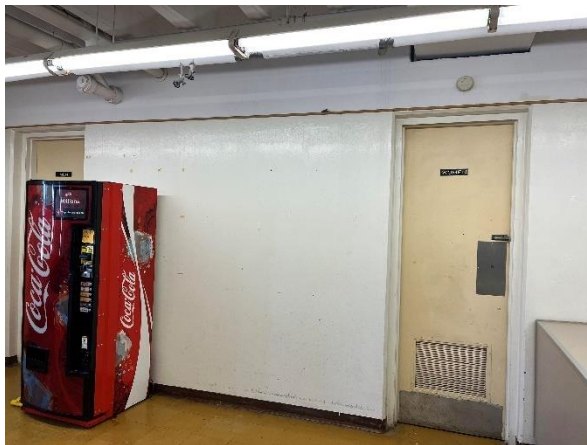
*Concession Area*

The Parkwood Swimming Pool facility offers vending concessions. The concessions area appeared to be in good condition during the visit inspection.

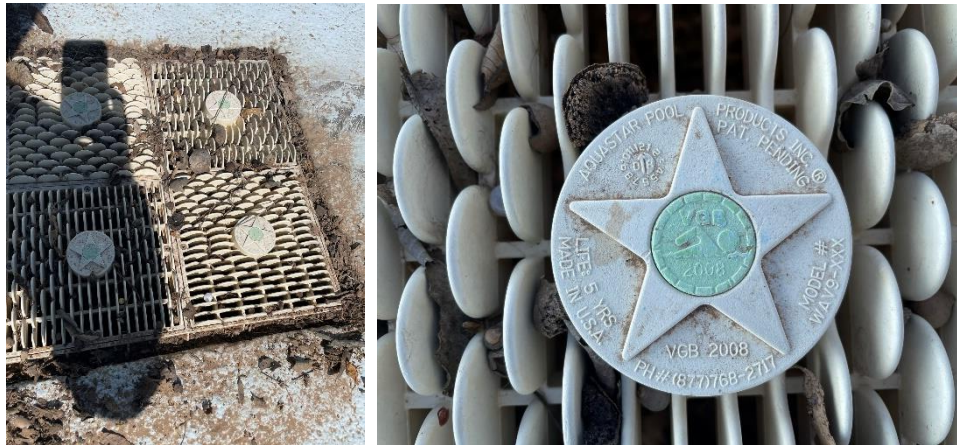
Drain grate covers will have a certified life span stamped on the unit based on the regulatory requirements and the material construction. If the facility is to remain in operation the covers should be replaced within the certified life span.

Staff report that the main drain grates were replaced recently which would mean the pool is currently in compliance. The drain grates were not available for viewing at site visits. Staff were searching for the documents from the installer to verify the certified life span.

1. Replace grate covers based on manufacturer's post certification date.

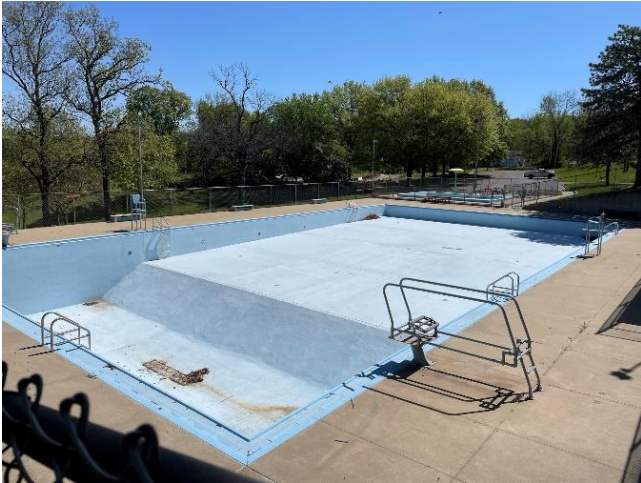
| Leaking main pool | Wading pool non-ADA compliant | Previous basin repairs |
| Rating: 1 out of 5 | Rating: 1 out of 5 | Rating: 3 out of 5 |

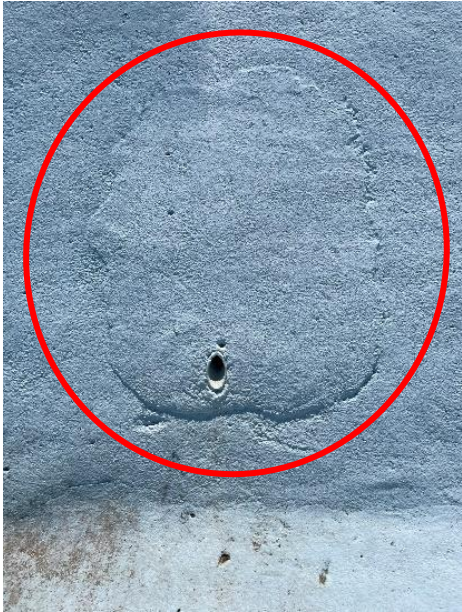
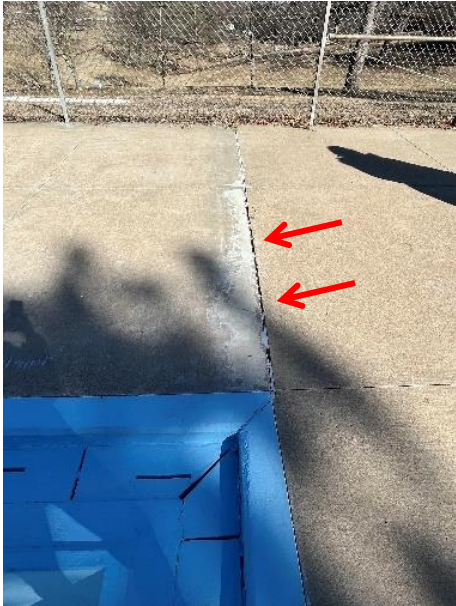
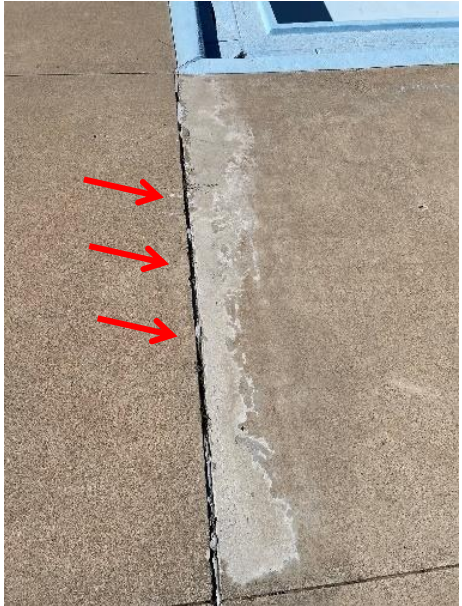
| Basin repairs | Deck movement | Basin repairs |
| Rating: 3 out of 5 | Rating: 3 out of 5 | Rating: 3 out of 5 |

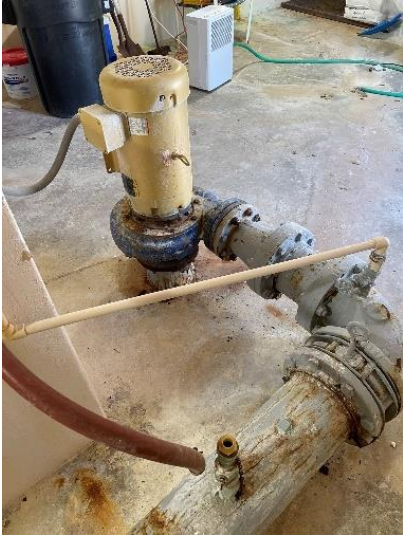
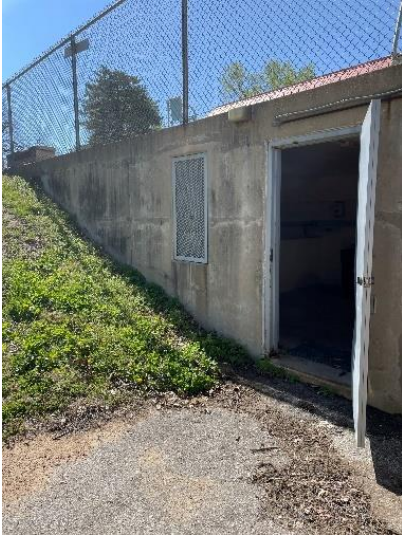
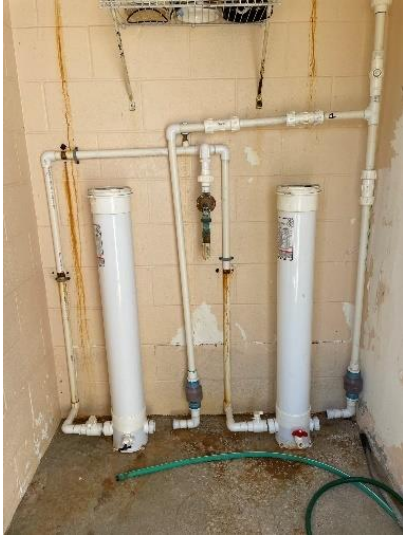
| Pipe corrosion | Filter area | Disinfection system – No control |
| Rating: 2 out of 5 | Rating: 3 out of 5 | Rating: 2 out of 5 |

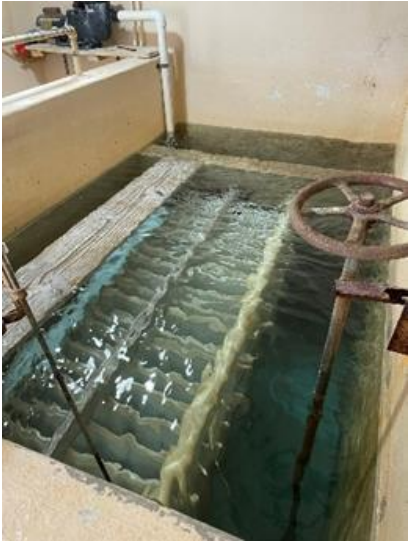
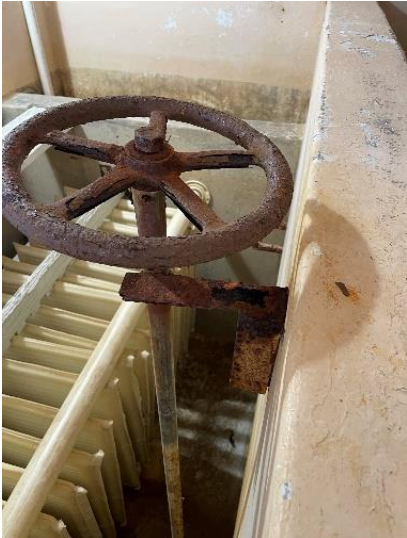
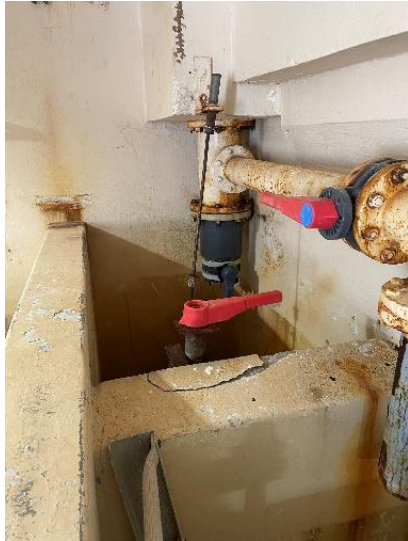
| Original filter | Pipe valve corrosion | Pipe corrosion |
| Rating: 2 out of 5 | Rating: 2 out of 5 | Rating: 1 out of 5 |

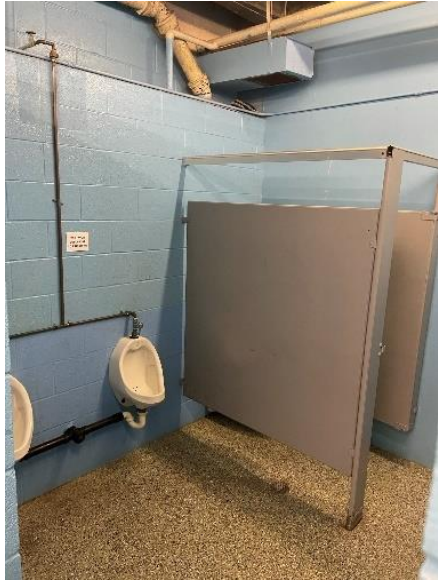
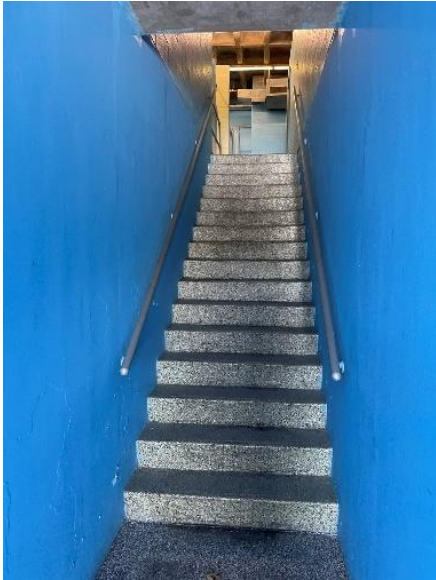
| Non-compliant ADA | Non-compliant ADA | Non-compliant ADA |
| Rating: 1 out of 5 | Rating: 1 out of 5 | Rating: 1 out of 5 |

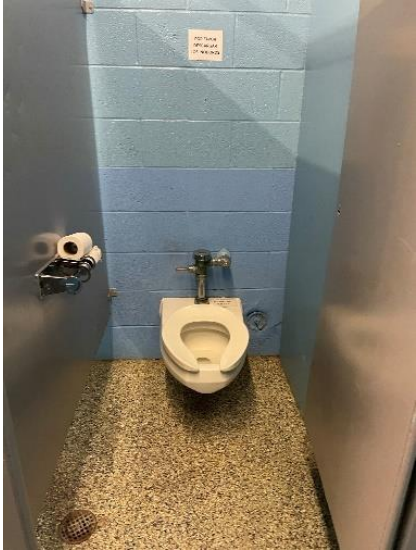
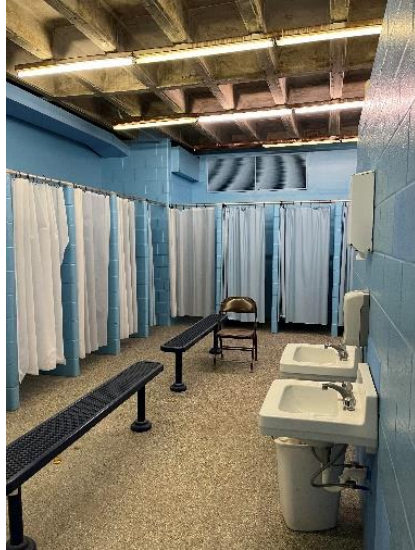
| Non-compliant ADA | Non-compliant ADA |
| Rating: 1 out of 5 | Rating: 1 out of 5 |
